# Community Preservation Committee Town of Arlington

Project Title: **Study of Spy Pond Field Bleachers**

## **SPY POND FIELD Assessment of Concrete Bleachers**

### **Final Report**

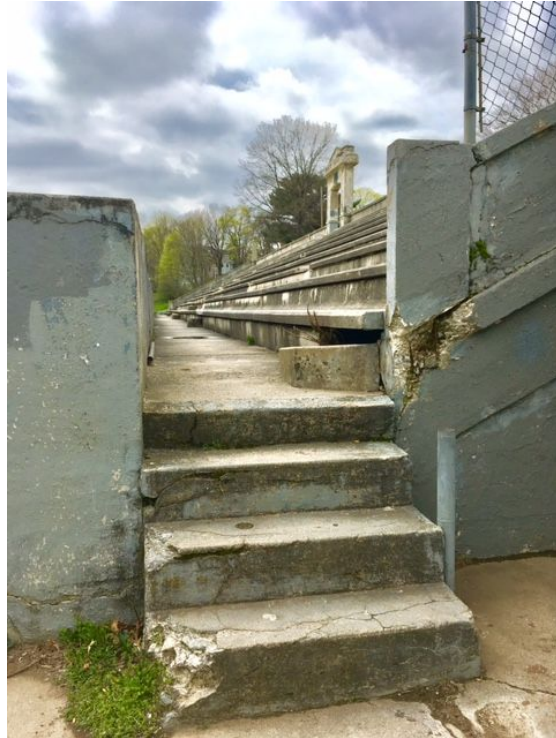
### Graffiti/Tagging

All vertical surfaces are regularly tagged.

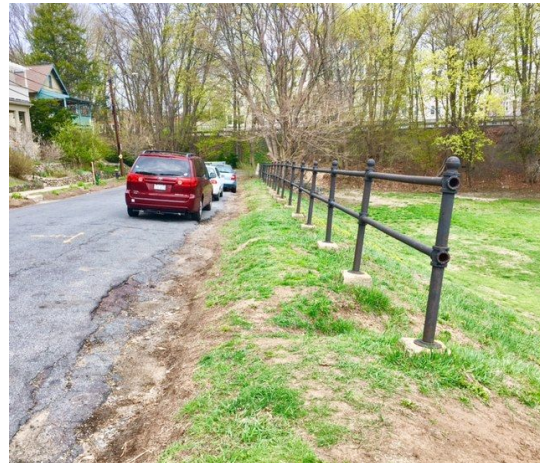
### Fence

The 100+ year old, original fence is broken and unstable in many places along Lombard Rd.

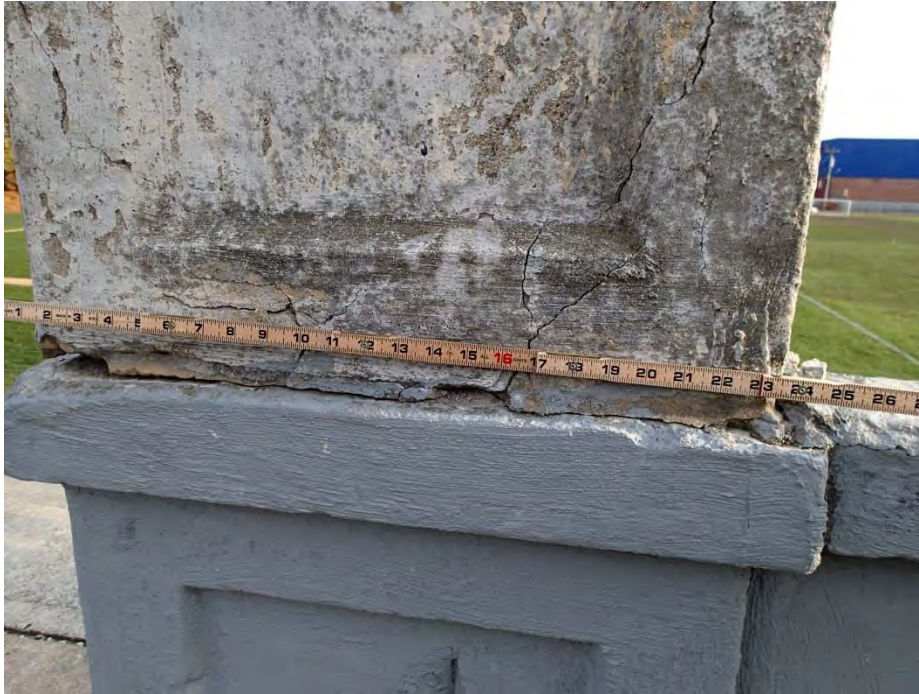
The lower portion of the concrete archway is cracked and experiencing widespread coating failure (Figure 7). There is a crack approximately 1/2 inch wide where the arch element intersects the west vertical column (Figure 8). This crack was previously repaired with mortar or sealant. The pediment above the concrete archway is significantly deteriorated at the horizontal surfaces and corners (Figure 9). Large concrete spalls, up to two feet long, were easily removed by hand during our field work (Figure 10). Biological growth is present at various locations on the pediment, indicating persistent exposure to moisture (Figure 11).

*Figure 7. Cracking and coating failure at base of concrete archway.*

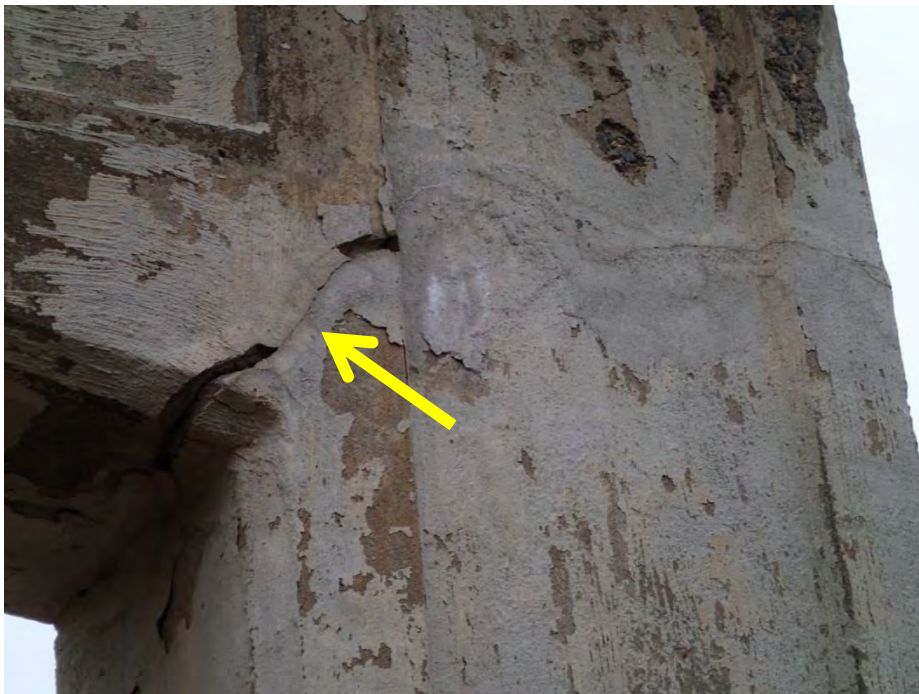
*Figure 8. Previously repaired crack where arch intersects column.*

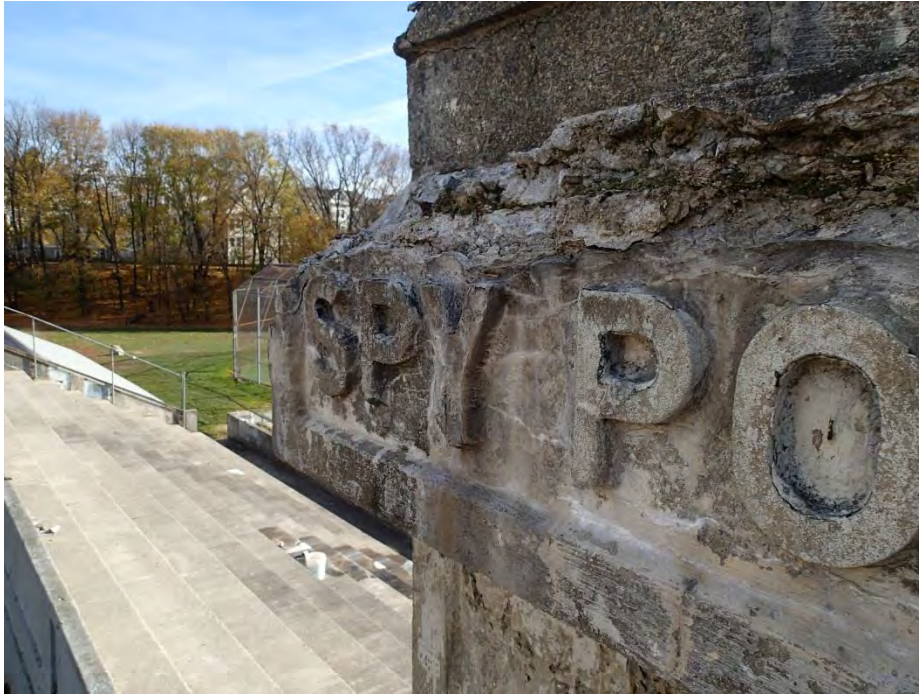
*Figure 9. Typical concrete deterioration at pediment above arch.*

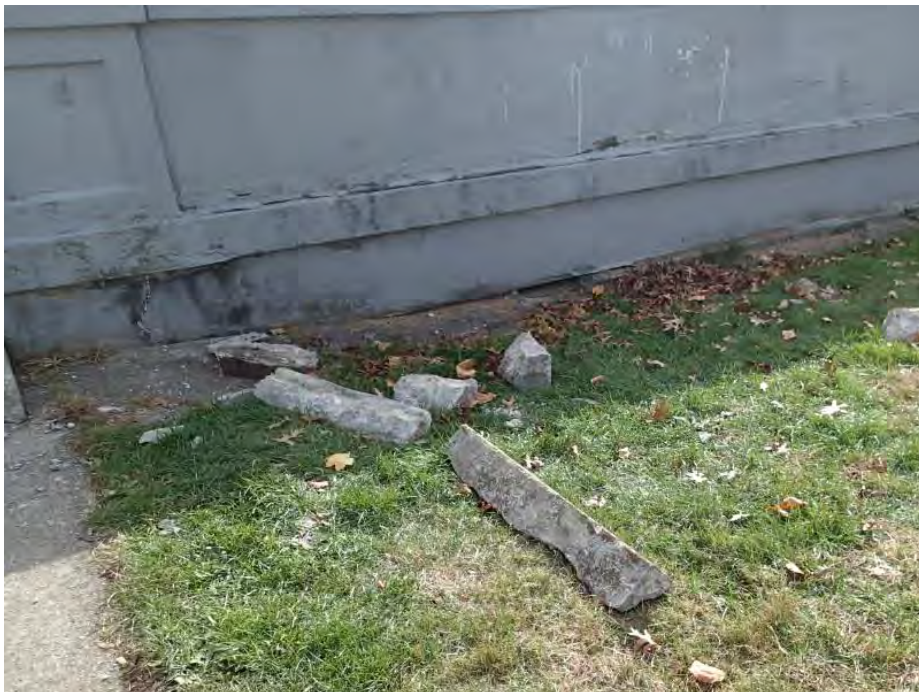
*Figure 10. Loose concrete sections removed from arch and pediment.*

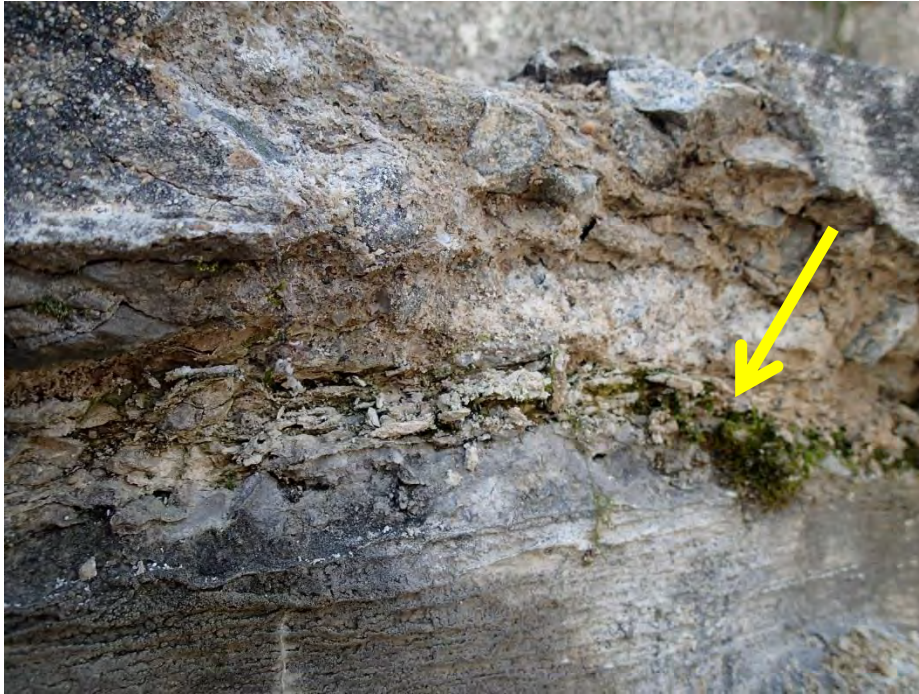
*Figure 11. Biological growth at distressed concrete above arch.*

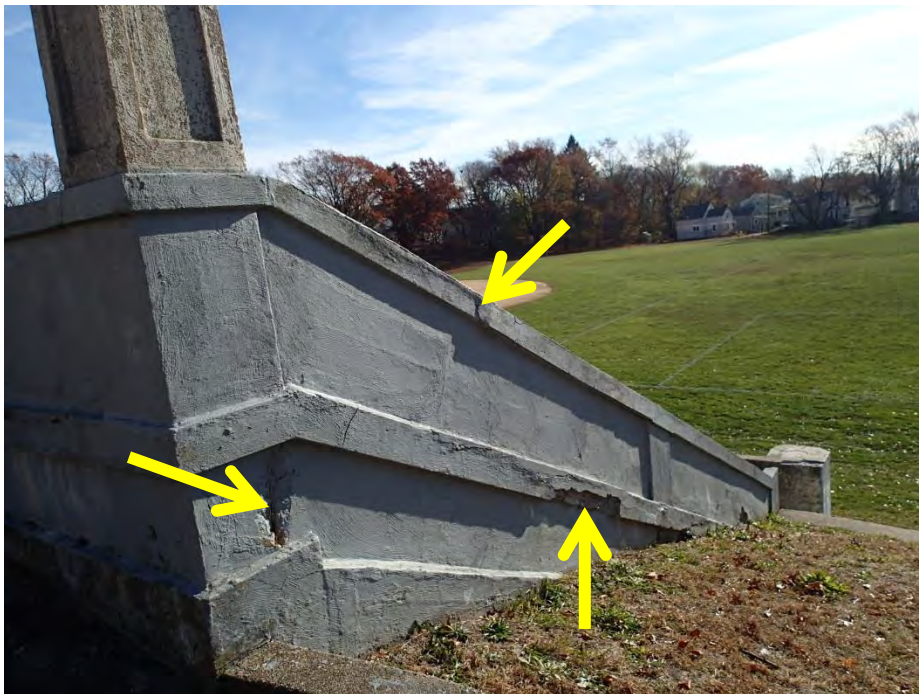
The perimeter walls at the sides and top of the bleachers are approximately three inches thick with a coping approximately five inches wide. These walls are typically cracked throughout and there are multiple spalls or incipient spalls with exposed corroded reinforcing steel (Figure 12). At the rear perimeter wall, there is a continuous horizontal crack that is approximately 1/2-inch wide, just below the coping (Figure 13).

*Figure 12. Perimeter wall with typical spalling and cracking.*

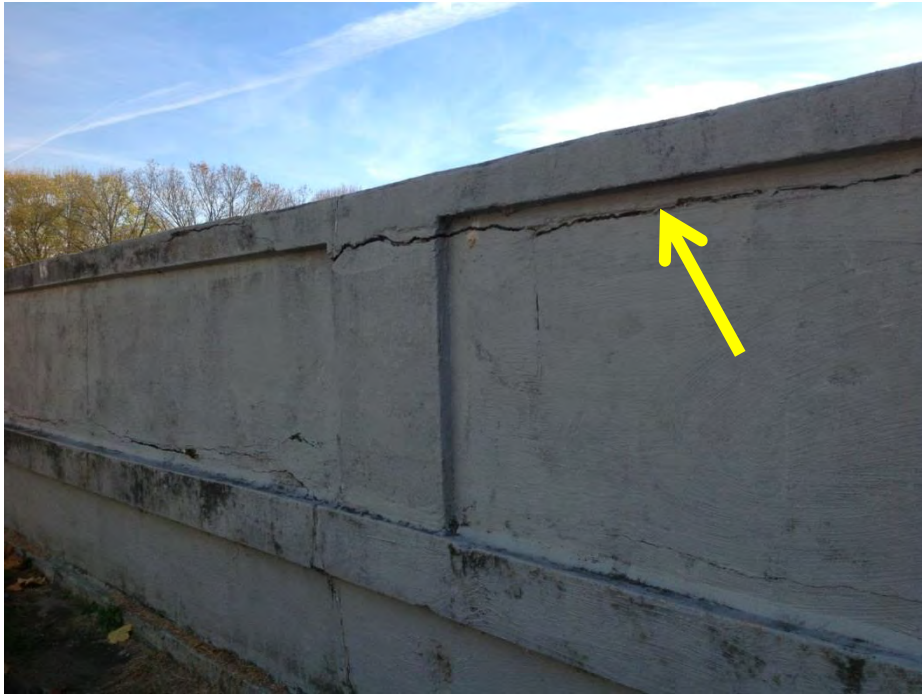
*Figure 13. Horizontal crack below coping at rear perimeter wall.*

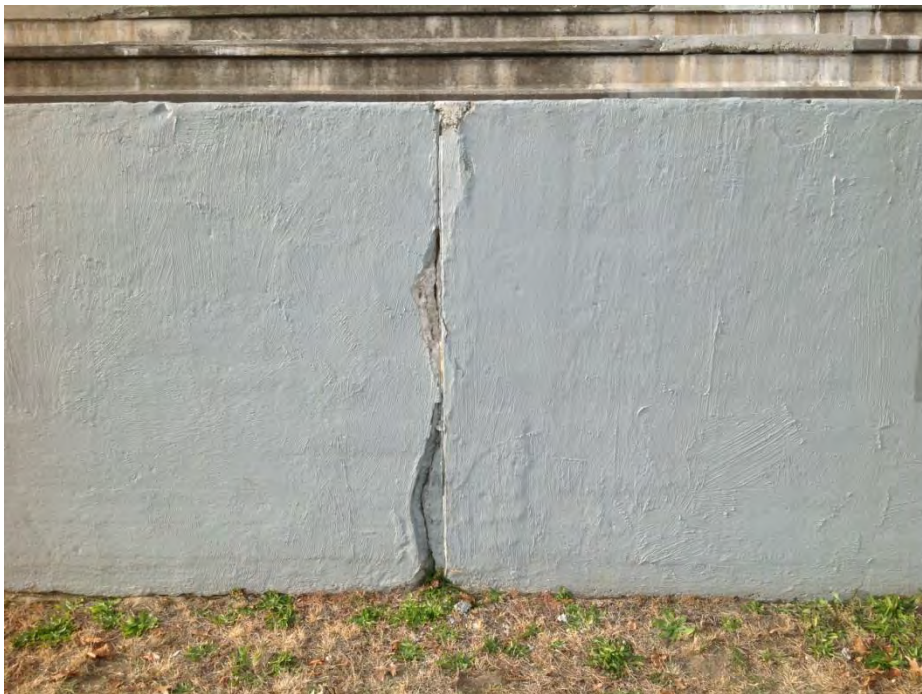
The perimeter wall at the base of the bleachers is approximately six inches thick and the outside vertical surface is treated with a grey coating. There are approximately ten vertical cracks within the wall, some of which are located at construction/control joints, and some that are accompanied by isolated areas of delaminated concrete (Figure 14). Approximately 50 to 75 percent of the top surfaces of the perimeter walls are delaminated.

*Figure 14. Perimeter wall at base of bleachers with cracks and spalled concrete at control joint.*

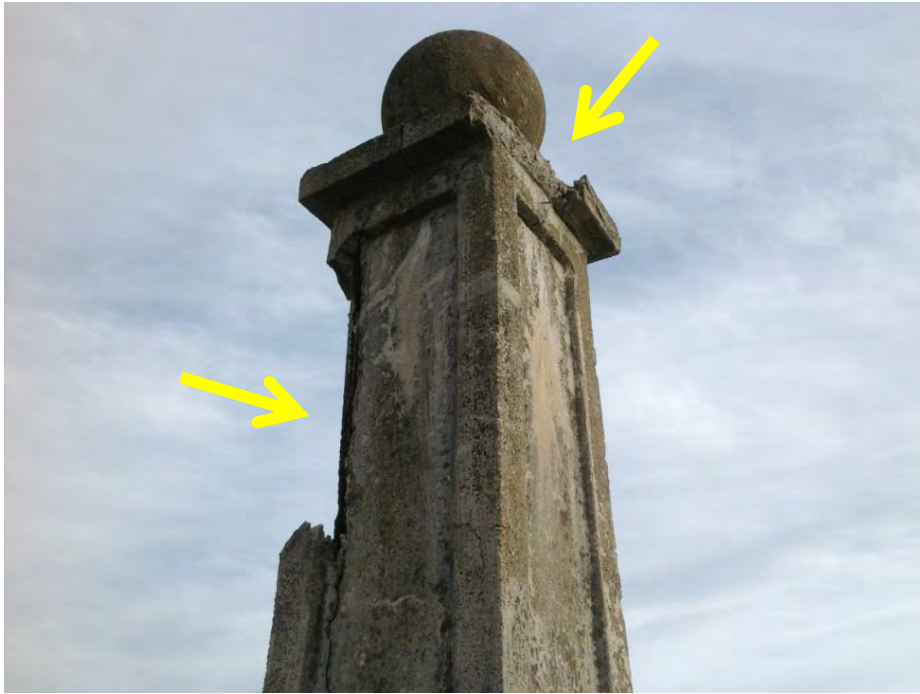
Decorative concrete pillars are located at each end of the upper perimeter wall. The pillars are square in plan and include a flat pediment with a concrete sphere at the top. The coating at both pillars has failed. At the west pillar there is a vertical concrete spall at the northeast corner that is approximately three feet long with exposed corroded reinforcing steel (Figure 15). The pediment at the top of this pillar is also spalled and there are vertical cracks extending from the body of the pillar up through the pediment

*Figure 15. Spalls at west concrete pillar.*

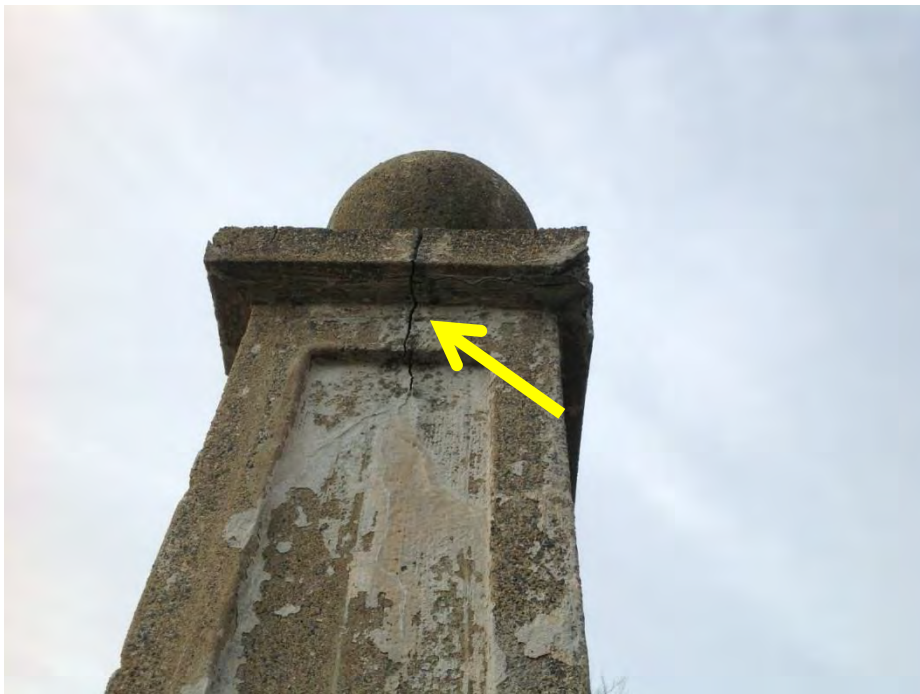
(Figure 16). The east pillar is less deteriorated; however, there is one vertical crack approximately four feet long located on the north face of the pillar in addition to four abandoned embedded anchors (Figure 17).

*Figure 16. Vertical crack at west concrete pillar.*

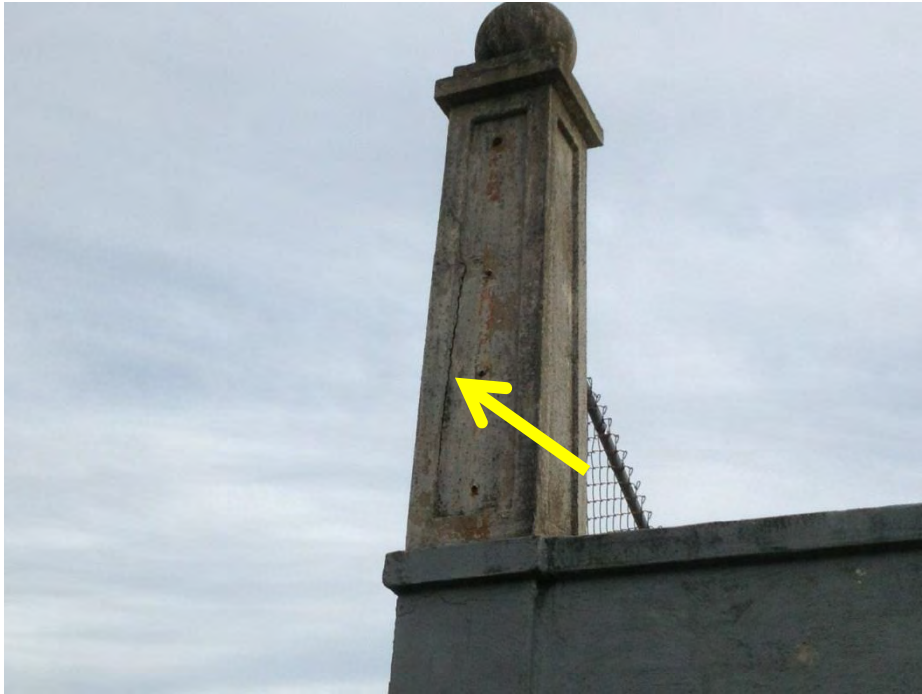
*Figure 17. Vertical crack and abandoned anchors at east concrete pillar.*

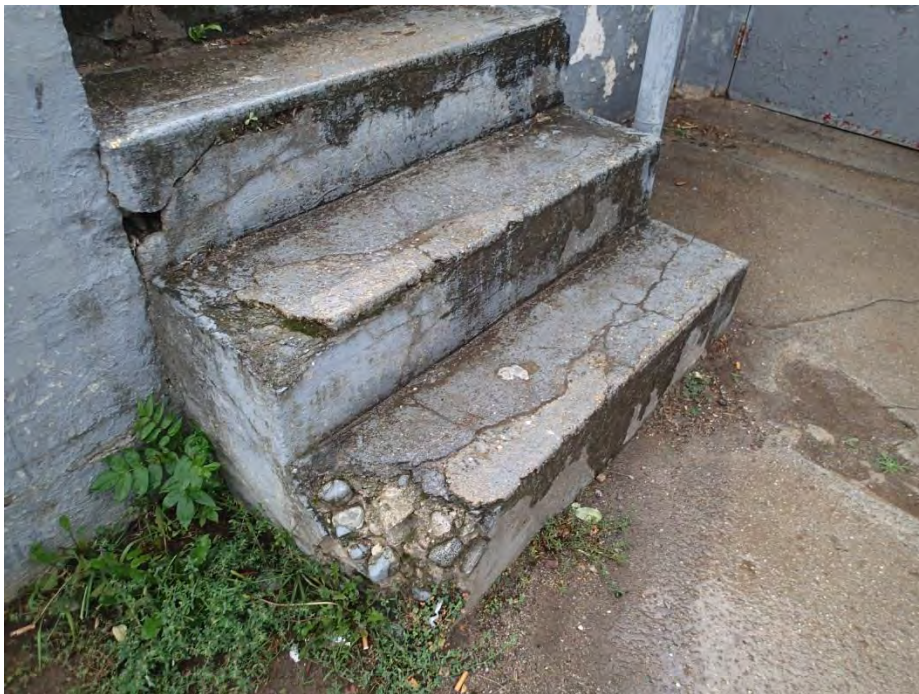
The concrete walkway at the base of the bleachers is typically in good condition with minimal distress. The field-level stairway at the east end of the bleachers is in poor condition with multiple cracks and spalls throughout (Figure 18). WJE attempted to remove a concrete core from a stair tread and noted the presence of large aggregate (up to 2 inches in diameter) and minimal cement paste.

*Figure 18. Cracked and spalled concrete at east field-level stairs.*

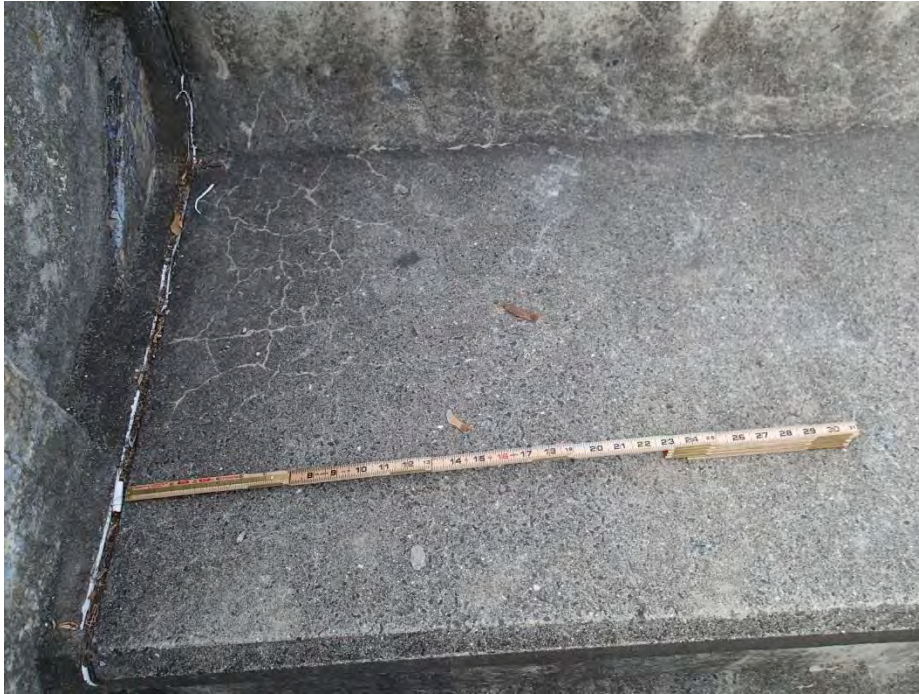
A fine network of interconnecting cracks (“map” cracking) is present on the horizontal surfaces at one or both ends of 31 of the 70 (approximately 44 percent) precast concrete seating element sections (Figure 19). Similar map-cracking is present at the sloped transition between the horizontal and vertical surfaces at most of the precast concrete seating elements (Figure 20). At isolated locations there is more pronounced cracking of the sloped transition and vertical surfaces at the ends of the seating elements (Figure 21). Control joints between precast concrete sections and along the perimeter walls are detailed with sealant and backer rod but the sealant joints have typically failed in adhesion or cohesion (Figure 22). Control joint widths vary from less than 1/4 inch to larger than 1 inch (Figure 23).

*Figure 19. Example of map cracking of horizontal surface at end of precast concrete seating elements.*

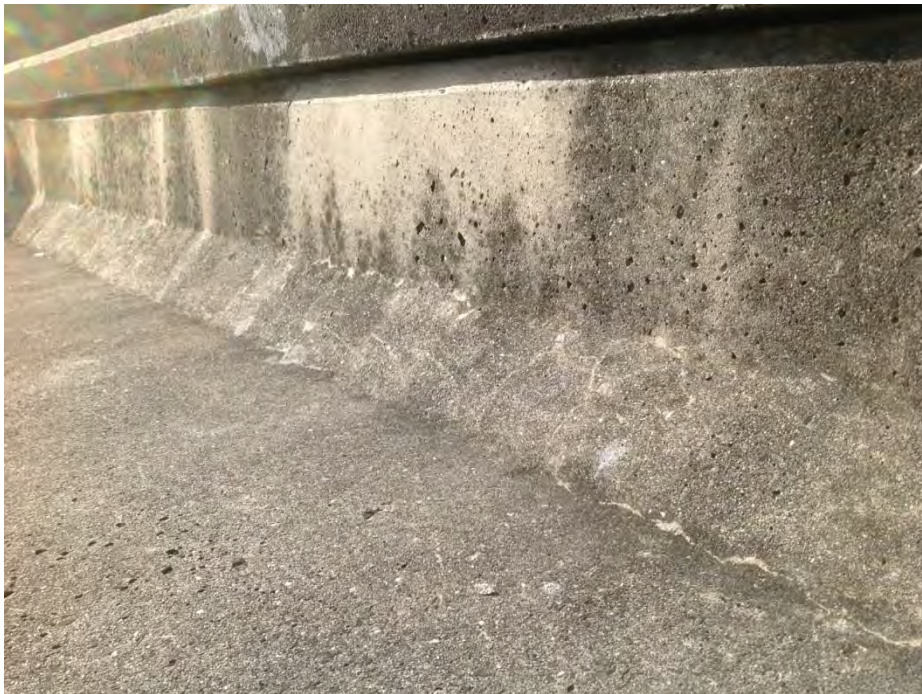
*Figure 20. Example of map-cracking at sloped transition between horizontal and vertical surfaces of precast concrete seating elements.*

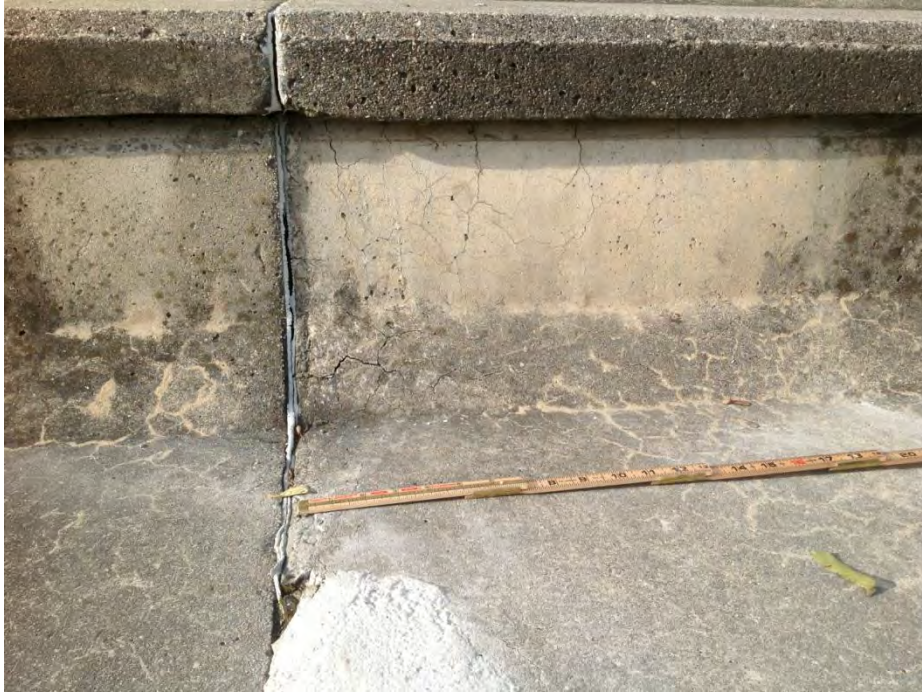
*Figure 21. Example of cracking at sloped transition and vertical surface at end of precast concrete seating element.*

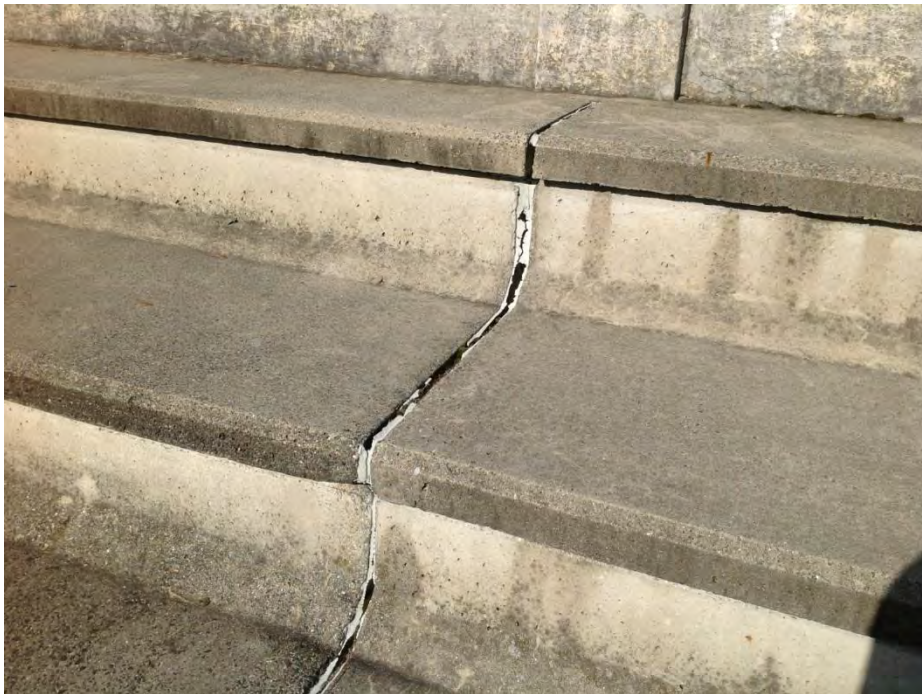
*Figure 22. Typical sealant failure at joint between precast concrete sections.*

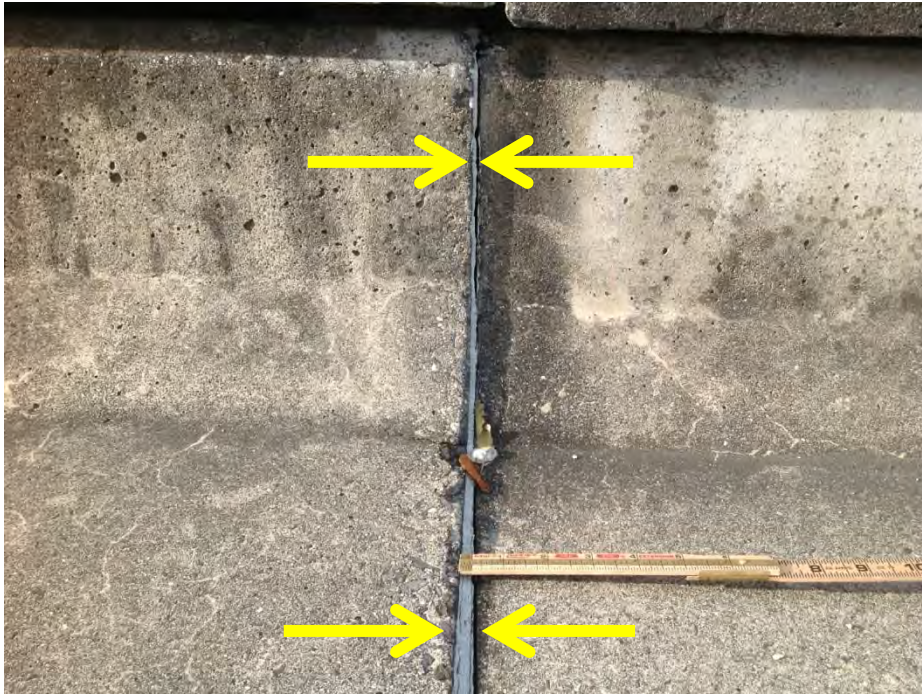
*Figure 23. Example of variation in joint width between precast concrete sections.*

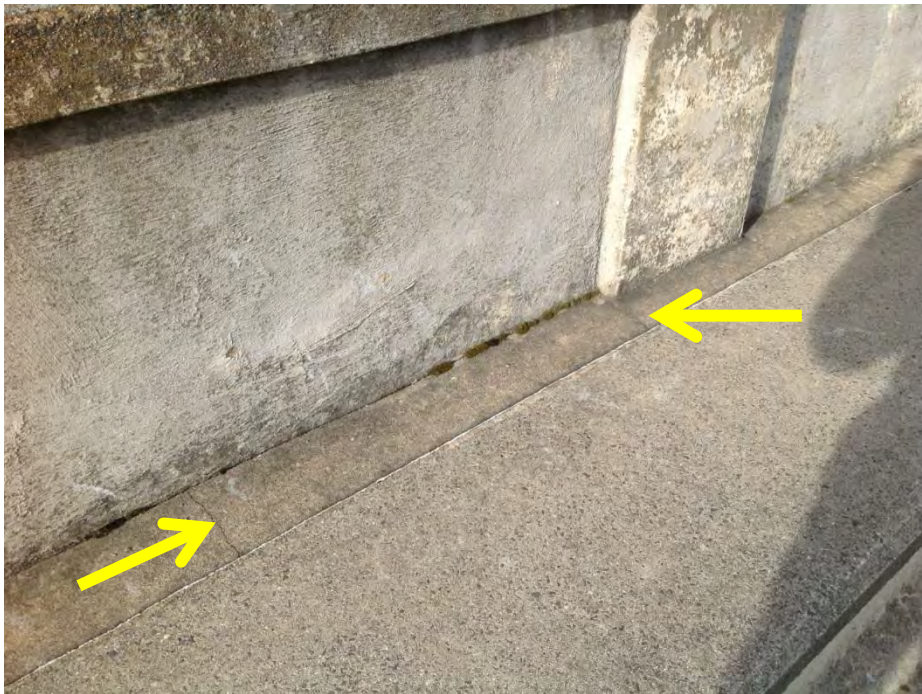
There are shrinkage cracks in the concrete pour strip installed between the precast concrete seating elements and the perimeter walls that run perpendicular to the walls (Figure 24). Cracking is also prevalent throughout each of the precast concrete stair treads that are located in the center of the bleacher structure between the field and the archway (Figure 25).

*Figure 24. Cracking of concrete pour strip between precast concrete seating element and perimeter wall.*

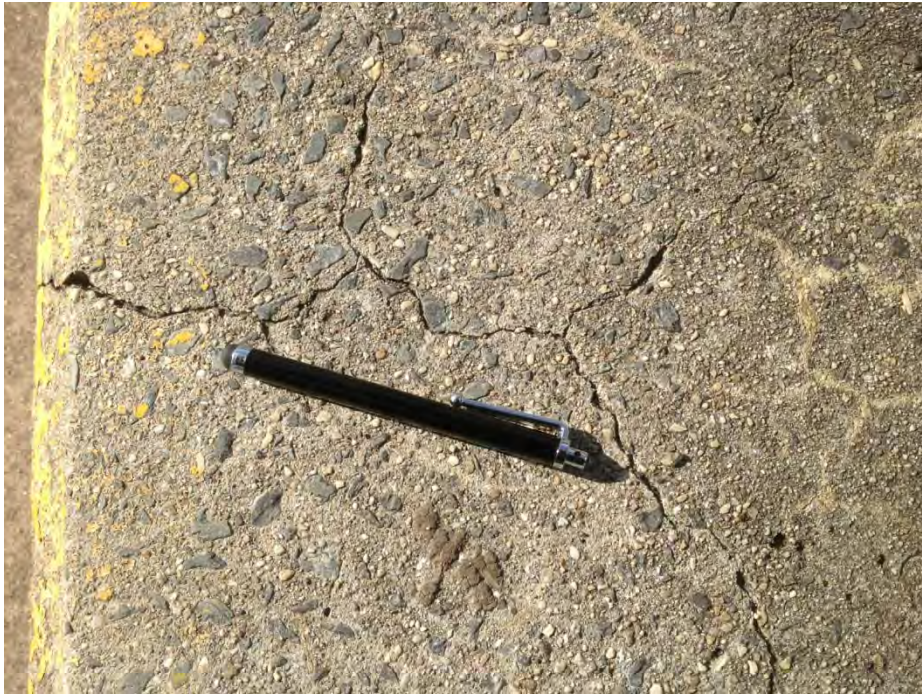
*Figure 25. Typical cracking of precast concrete stairs.*

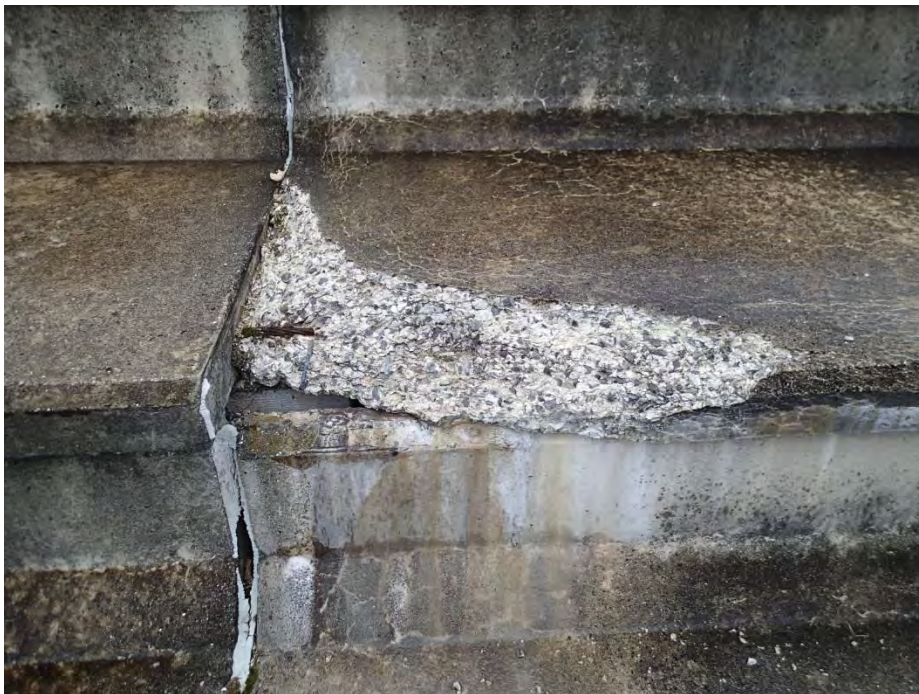
During our first site visit, WJE observed seven existing concrete spalls located at the ends of precast concrete seating elements (Figure 26). When we returned for the full survey, these spalls had been repaired by others (Figure 27). Additional spalls at the edge of one seating element (adjacent to a patch repair) were not yet repaired (Figure 28). During the field survey, WJE also removed delaminated concrete at one seating element location that had not previously been repaired (Figure 29).

*Figure 26. Example of spall at corner of precast concrete seating element observed during initial site visit.*

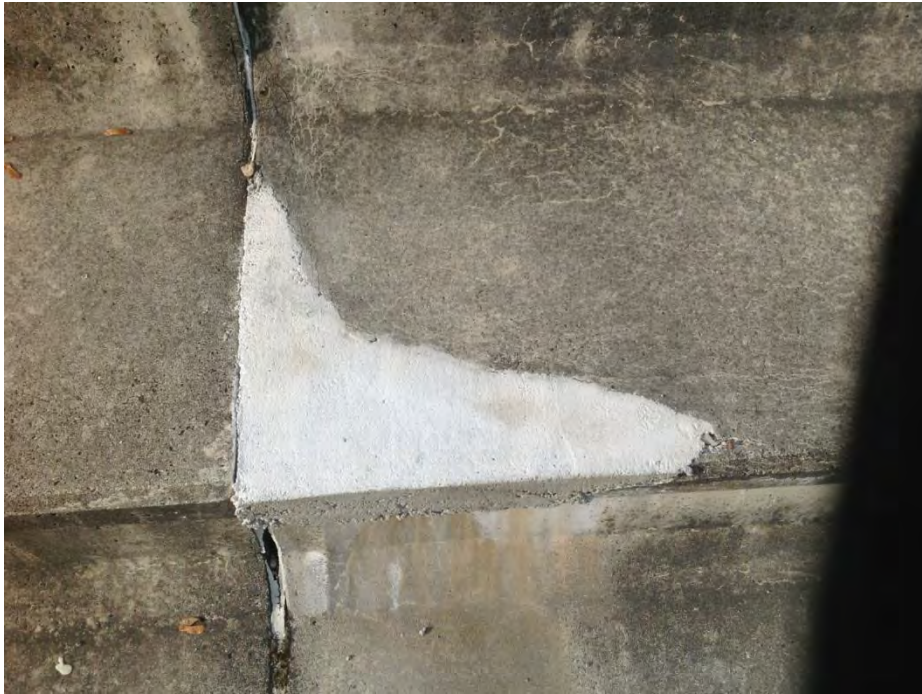
*Figure 27. Patch installed by others at spalled concrete shown in Figure 26.*

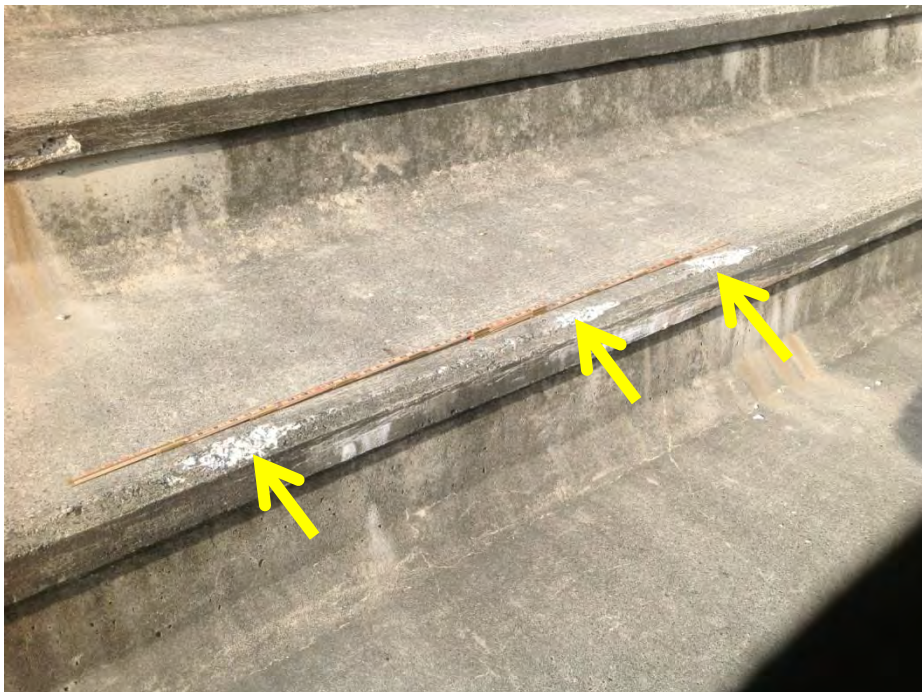
*Figure 28. Existing concrete spalls at edge of seating element.*

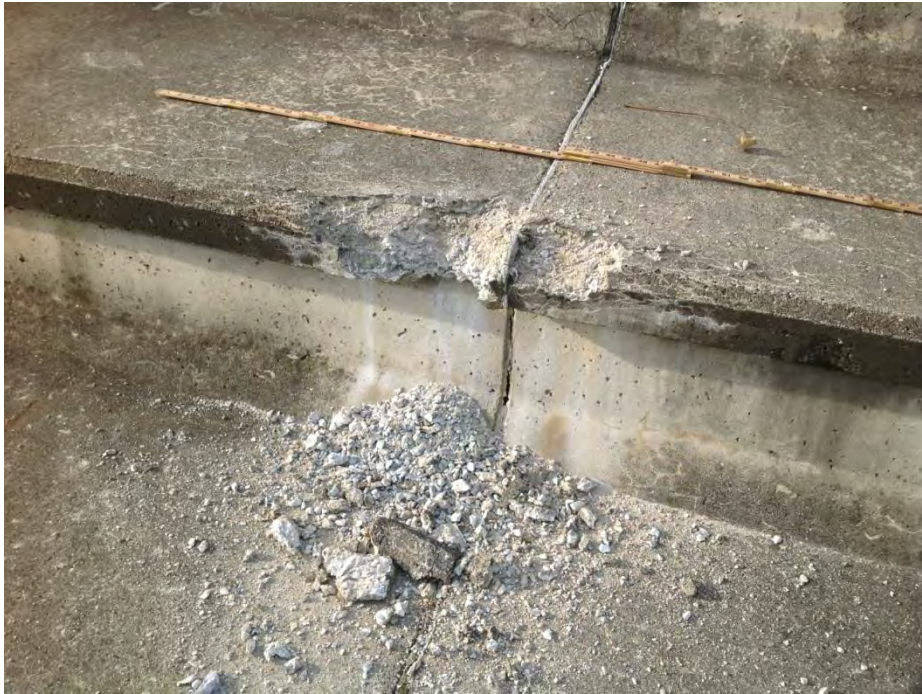
*Figure 29. Delaminated concrete removed by WJE during the survey.*

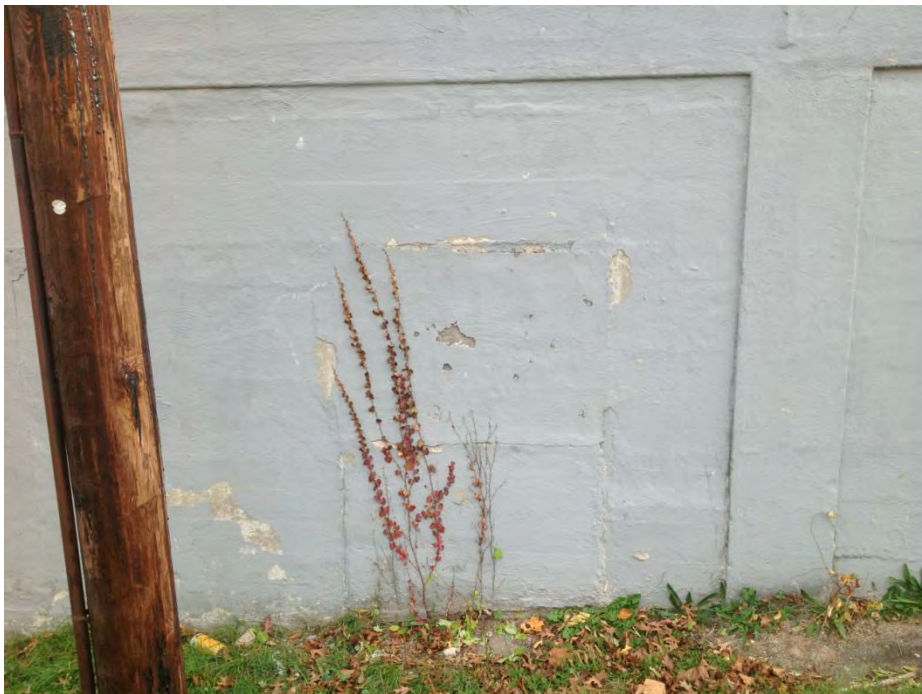
The west end of the maintenance and locker room building extends under the concrete bleachers. Portions of the foundation and perimeter walls are visible from inside the restroom/shower area. There are three windows at the rear perimeter wall that open to the restroom/shower area; two are boarded up with an opaque infill panel (Figure 30) and the other filled with a Plexiglas panel in a rotted wood frame covered by a corroded and displaced metal grate (Figure 31). It appears that the ceiling of the restroom/shower area is constructed of board-formed concrete, which is assumed to be a separate structure from the precast concrete seating elements above. There is evidence of ongoing water penetration at the ceiling in the form of staining and peeling coating (Figure 32).

*Figure 30. Window filled with opaque panel.*

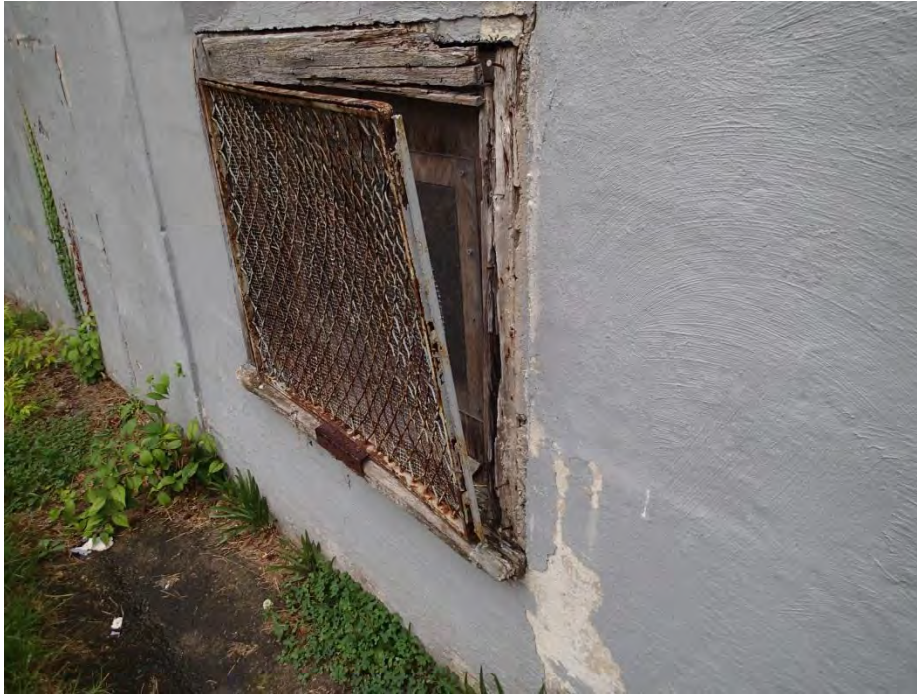
*Figure 31. Window with rotted wood trim and frame plus a corroded and displaced metal grate.*

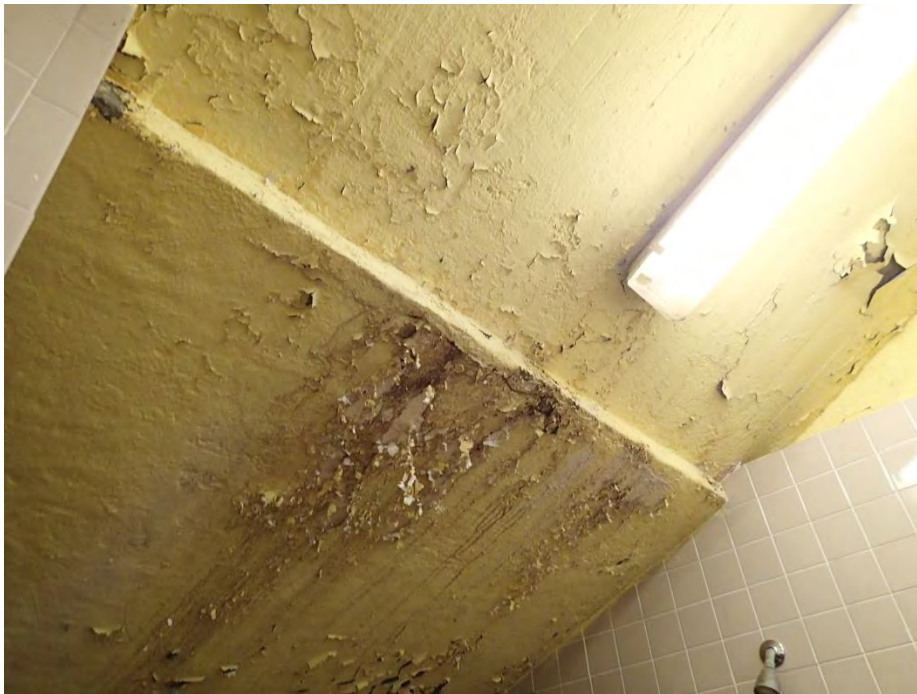
*Figure 32. Evidence of water infiltration at shower area ceiling.*

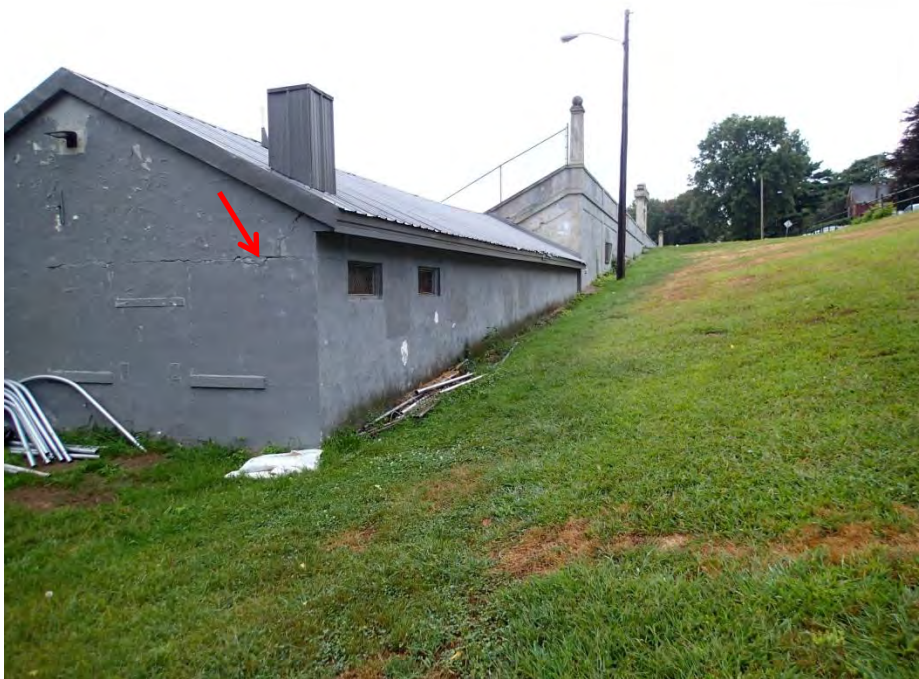
The remaining portion of the maintenance and locker room building lies outside of the bleachers and is covered by a corrugated sheet metal roof (Figure 33). There is a large horizontal crack at the northeast corner of the building measuring approximately 1/2-inch wide with peeling coating on all three sides of the building (Figure 34).

*Figure 34. Horizontal crack (arrow) at northeast corner of locker room and maintenance building and coating failure.*

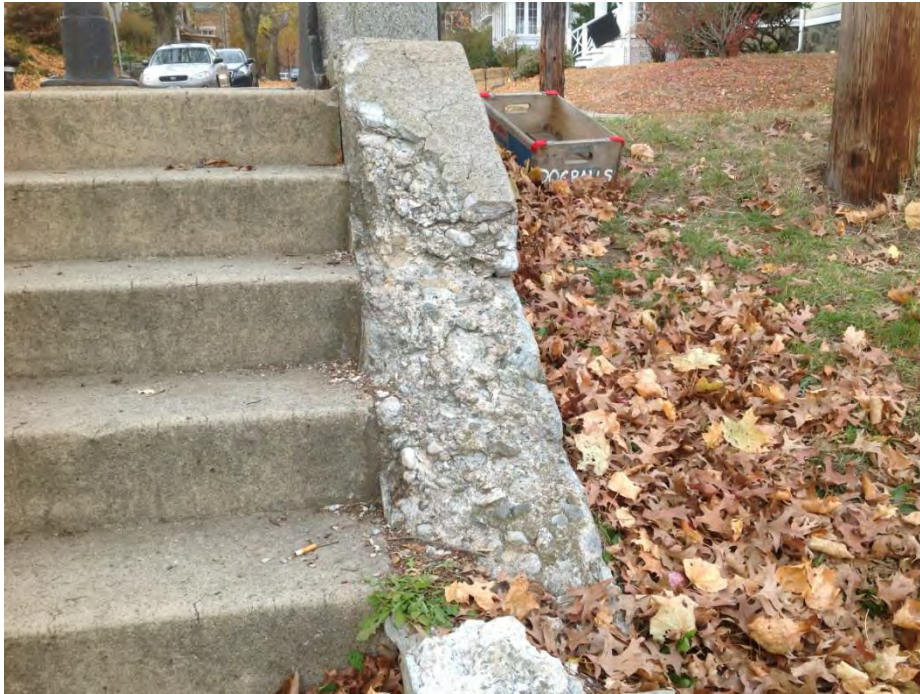
The site stairs adjacent to the bleachers contain areas of spalled and cracked concrete on the foundation walls on both sides of the treads (Figure 35). The spalled areas range in size from about two square feet up to ten square feet. Other sections of the foundation walls appear to be delaminated (Figure 36). The stair treads are less deteriorated but there are visible spalls and cracks (Figure 37). Some treads appear to have been patched previously. There are no handrails along the stairway.

*Figure 35. Spalled concrete at site stair foundation wall.*

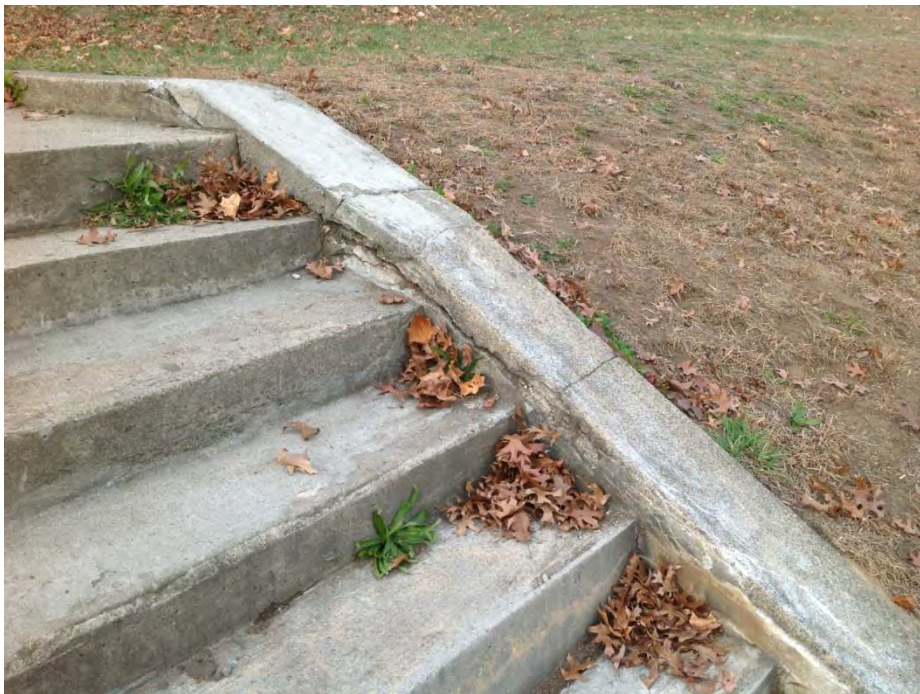
*Figure 36. Delaminated concrete at site stair foundation wall.*

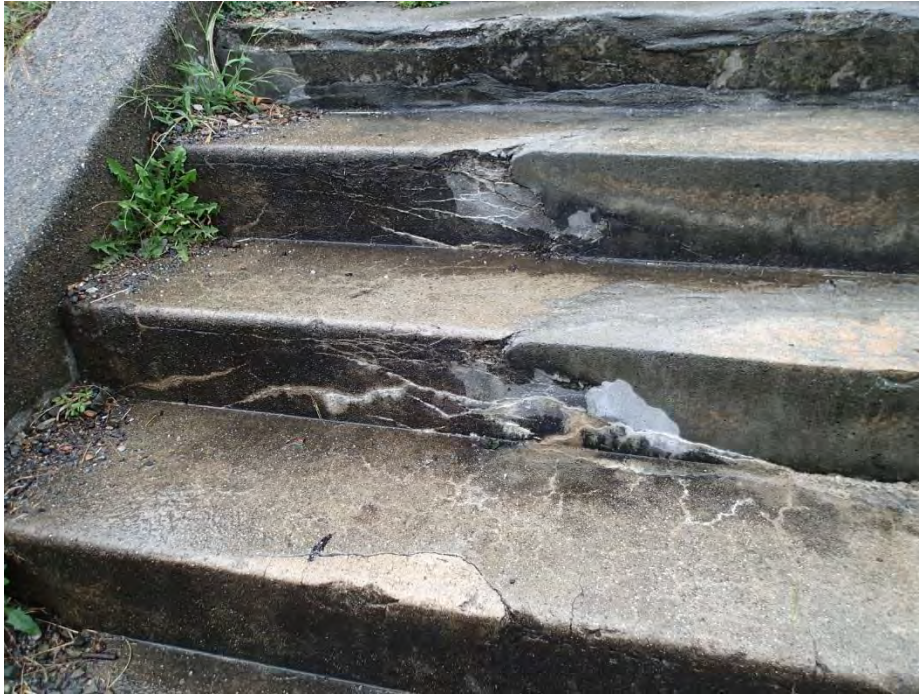
*Figure 37. Cracks and spalls at stair treads.*
